Blue Mountains Heritage Register Review

Heritage Inventory - 2016 Heritage Review

Item Name: **Wilson Park Water Feature (Map of Australia)**

Location: **2-16 St Bernards Drive, Lawson [Blue Mountains]**

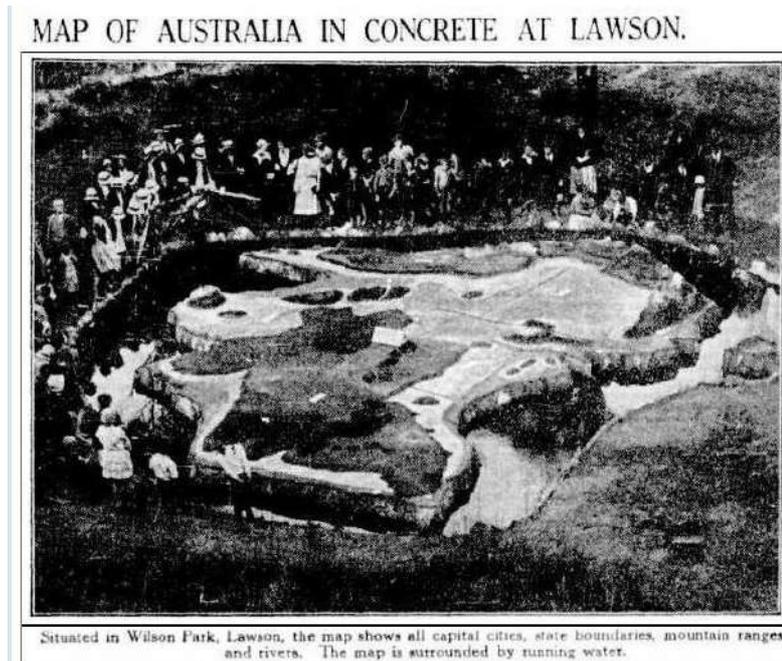
Caption: c1932 Another image of the official opening of the contour map of Australia, Wilson Park, Lawson. The detail and tonal qualities of the map are more evident in this image.

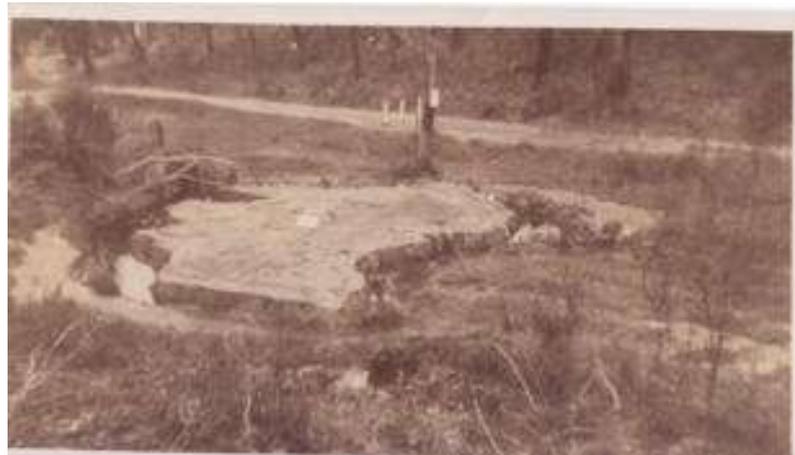
Caption: c1931 The map under construction on site

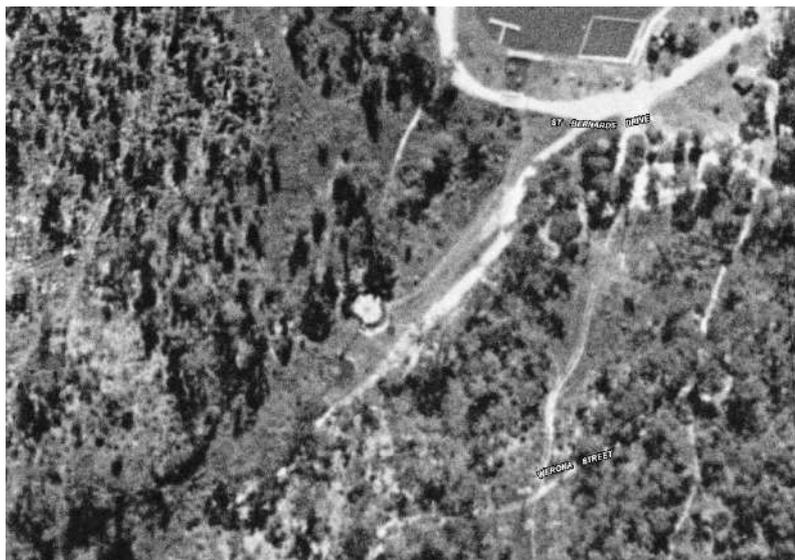
Caption: Wilson Park (Part) and Water Feature. There appears to be another earlier pond to the south-west.

Modification Dates: The c1943 aerial photograph suggests that the construction appears to have occurred in stages with the central ponds initially constructed and the westerly channels subsequently added to the arrangement. The photograph also suggests that there may have been another circular pond located on the eastern edge of the park and connected with a short channel.
